Mold Visual Moisture Inspection Report

May 30, 2026

421 Moisture Check V3 QA 20260530-025725-158, Austin, TX 78704

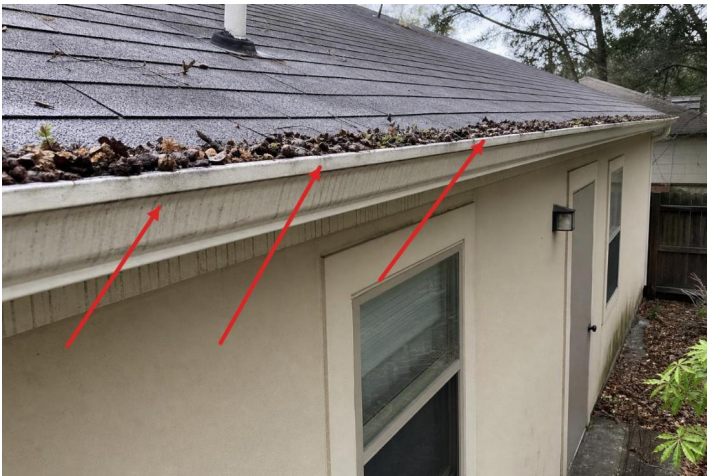
Roof - A debris-filled rear gutter was observed, and staining was present below the eave at the laundry-side wall, consistent with evidence of moisture intrusion at that location.

Defects: Drainage concern; Evidence of moisture intrusion; Staining observed

Notes: Debris-filled rear gutter and staining below the eave were observed at the laundry-side wall.

Roof 2.1a - Roof covering and drainage related to moisture intrusion

Clean the rear gutter promptly to restore proper drainage. Inspect and repair any damaged gutter sections, hangers, or downspout connections. Investigate and address the source of the eave staining at the laundry-side wall to prevent continued moisture entry.

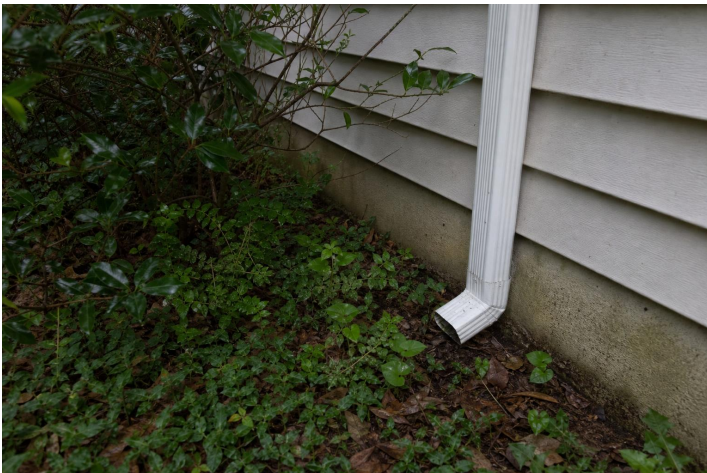
Exterior and Grounds - The rear downspout discharged near the foundation, directing water toward the structure. Dense vegetation was in contact with the wall cladding, retaining moisture against exterior surfaces. Both conditions are moisture-conductive.

Defects: Downspout discharge near foundation; Vegetation contact; Moisture-conducive condition

Notes: Rear downspout discharged near the foundation and dense vegetation contacted the wall cladding.

Exterior and Grounds 3.2a - Exterior grading and drainage around the inspected building perimeter.

Extend or redirect the rear downspout to discharge water at least six feet away from the foundation. Remove or trim vegetation so that a clear gap exists between plant material and wall cladding to allow surfaces to dry and reduce sustained moisture contact.

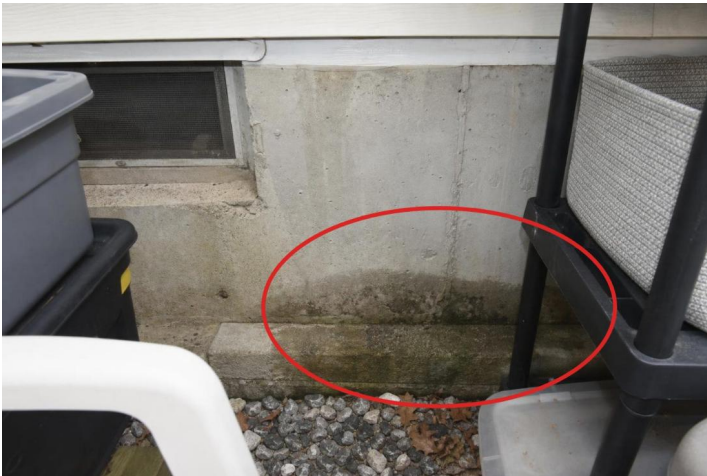
Notes: QA seed: inspected with no correction needed.

Foundation and Crawlspace 4.1a - Foundation, basement, or crawlspace moisture intrusion

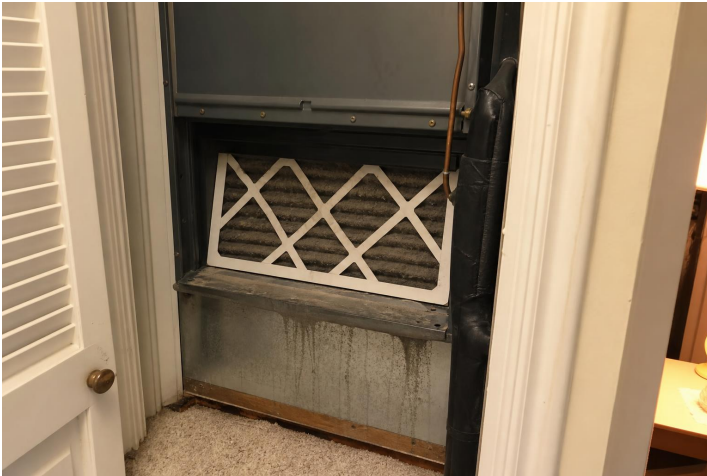
HVAC and Ventilation - The air handler filter was dirty. Moisture staining was visible at the adjacent return plenum, indicating past or ongoing moisture presence in that area.

Defects: Dirty filter; Moisture staining

Notes: Air handler filter was dirty and moisture staining was visible at the adjacent return plenum.

HVAC and Ventilation 5.1a - Air handler and filter area reviewed for moisture and growth indicators.

Replace the air handler filter immediately. Have an HVAC technician inspect the return plenum for the source of moisture staining and evaluate whether remediation or component repair is needed before resuming normal system operation.

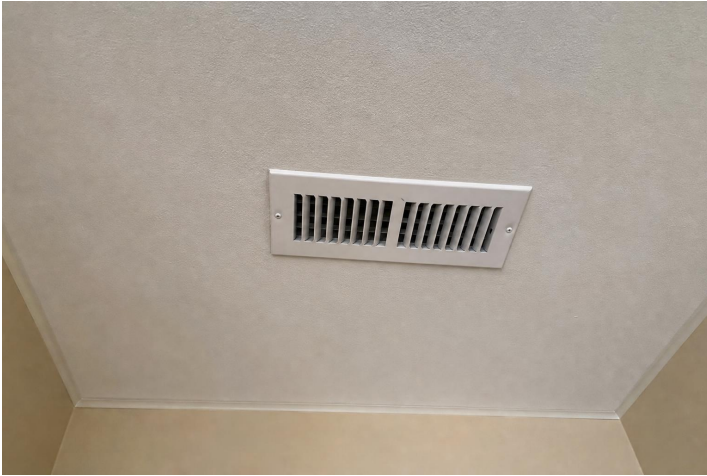
Notes: QA seed: inspected with no correction needed.

HVAC and Ventilation 5.3a - Representative supply register and surrounding finish condition.

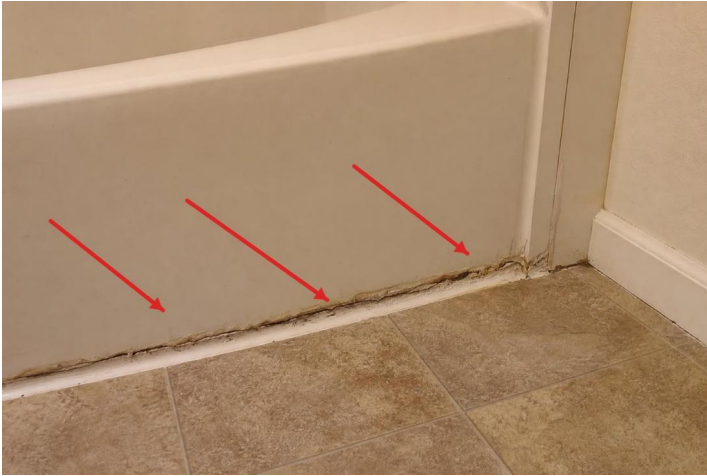
Plumbing - The guest bathroom tub surround had deteriorated caulk and grout. Elevated moisture readings were recorded at the adjacent base trim, and water damage indicators were noted nearby.

Defects: Deteriorated caulk/grout; Water damage nearby; High moisture reading

Notes: Guest bathroom tub surround had deteriorated caulk and elevated moisture readings at the adjacent base trim.

Plumbing 6.2a - Fixtures related to moisture intrusion

Remove deteriorated caulk and regrout or recaulk the tub surround completely with an appropriate waterproof sealant. Investigate the source of elevated moisture at the base trim; replace or repair any water-damaged materials as needed. Monitor the area after repairs to confirm moisture levels return to normal.

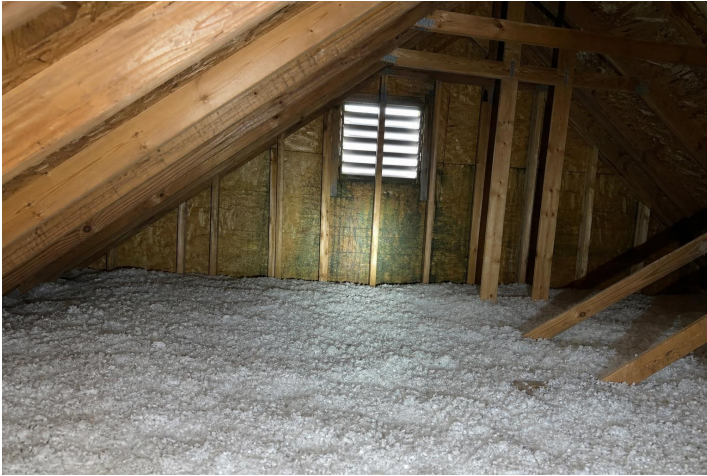
Notes: QA seed: inspected with no correction needed.

Attic, Ventilation, and Insulation 7.1a - Attic insulation and ventilation reviewed for moisture-related conditions.

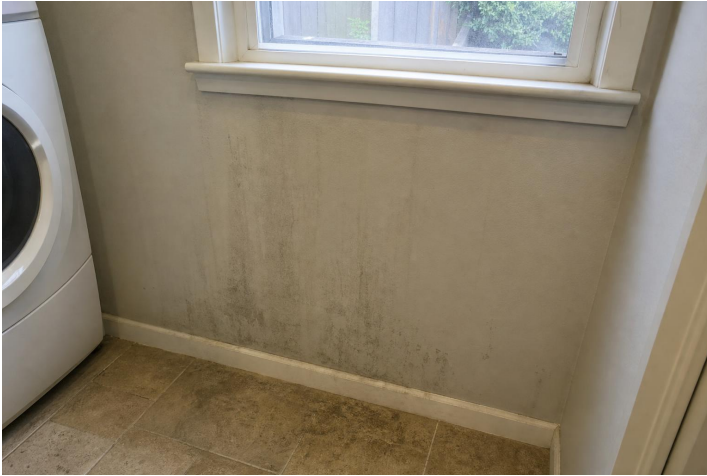
Defects: Water staining; High moisture reading; Musty odor

Notes: Laundry wall below the rear window had staining, a musty odor, and elevated moisture meter readings.

Interior 8.1a - Interior wall and ceiling area checked for staining or moisture indicators.

Identify and correct the source of moisture intrusion at the rear laundry wall, which may be related to the debris-filled gutter and downspout conditions observed at the exterior. After the source is corrected, assess affected wall materials for remediation. A musty odor with elevated moisture readings warrants further investigation by a qualified mold remediation professional if conditions do not resolve after the source is addressed.

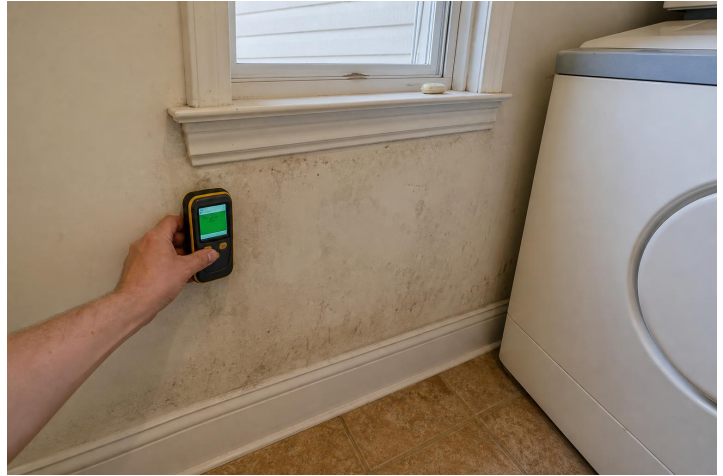
Interior - The laundry area wall below the rear window exhibited water staining and a musty odor. Elevated moisture meter readings were recorded at this location, indicating active or recent moisture intrusion.

Interior 8.1b - Moisture meter location at the stained laundry wall below the rear window.

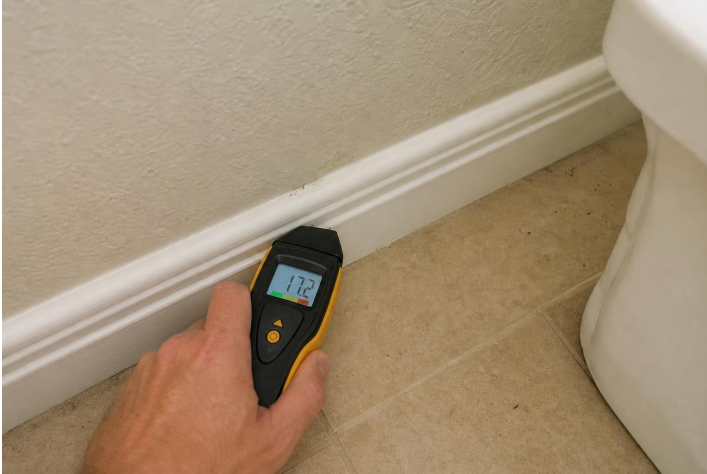
Moisture, Humidity, and Temperature - Elevated moisture readings were recorded at the laundry area wall and at the guest bathroom base trim. These readings correlate with the visible staining and odor findings documented in the Interior and Plumbing sections.

Defects: Elevated moisture reading; Moisture detected

Notes: Elevated moisture readings were recorded at the laundry wall and guest bathroom base trim.

Moisture, Humidity, and Temperature 9.1a - Representative moisture meter location for area of concern.

Address the identified moisture sources at the laundry wall and guest bathroom as described in the relevant sections. Re-test moisture levels after repairs are completed to confirm materials have dried to acceptable levels. If readings remain elevated, consult a qualified remediation professional for further evaluation.
